AFGL-TR-84-0069

ANTENNA PERFORMANCE VERIFICATION AT LAUNCH SITE

A Feasibility Study on Preflight Performance Testing of Stripline Slot Arrays Mounted on a Rocket

Scientific Report No. 2

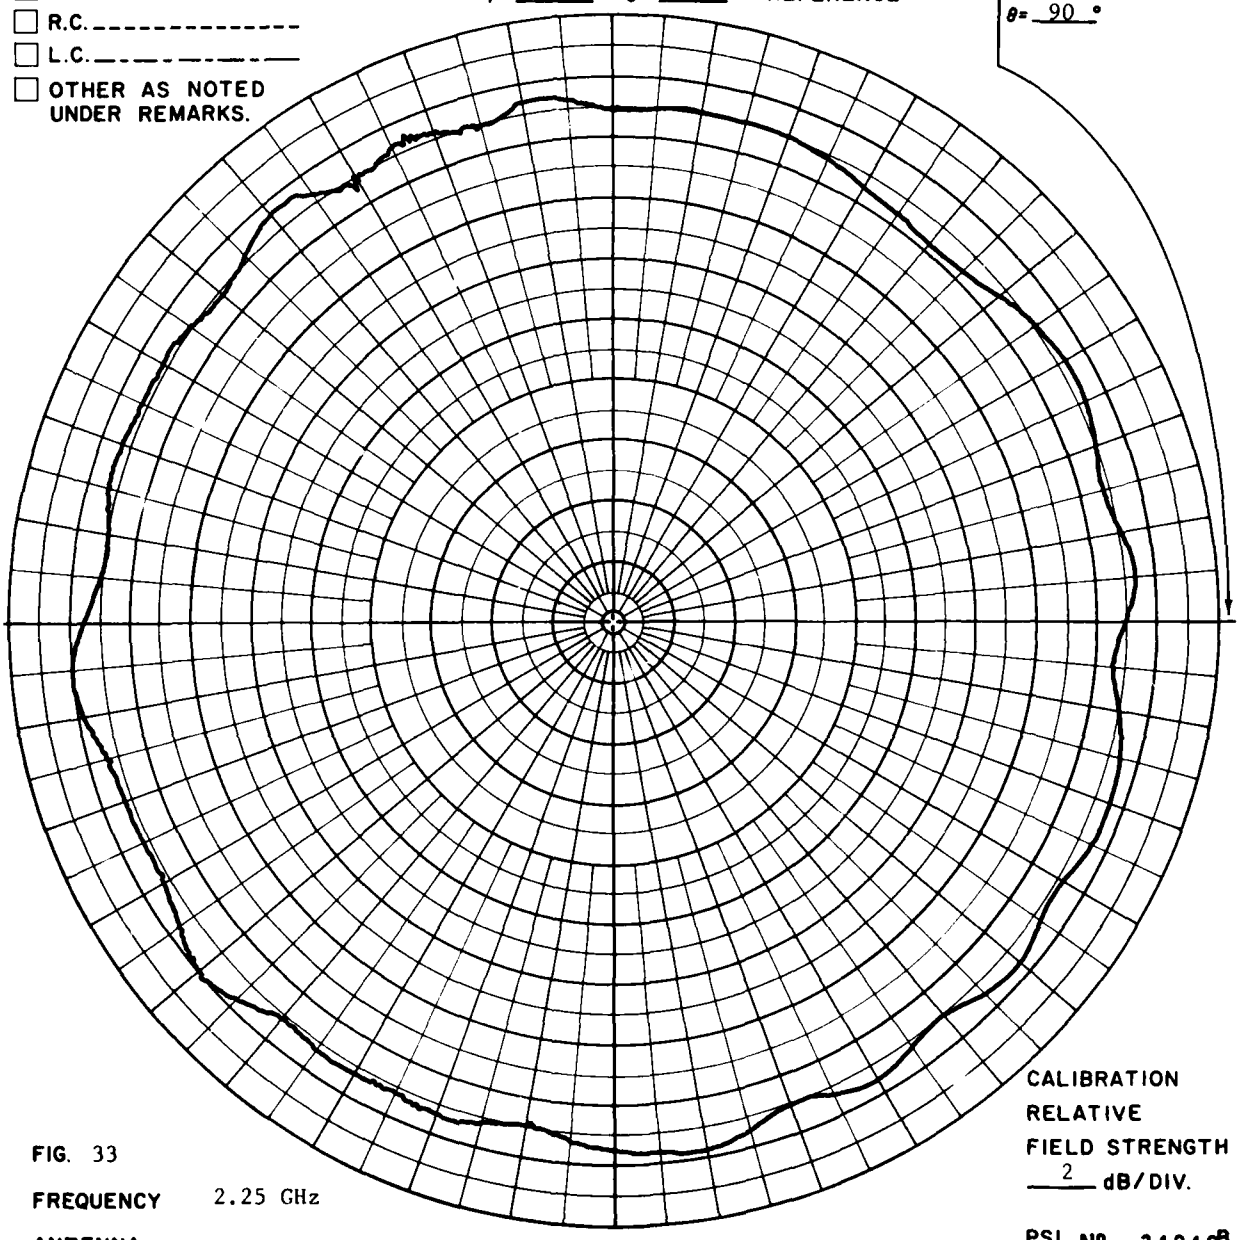
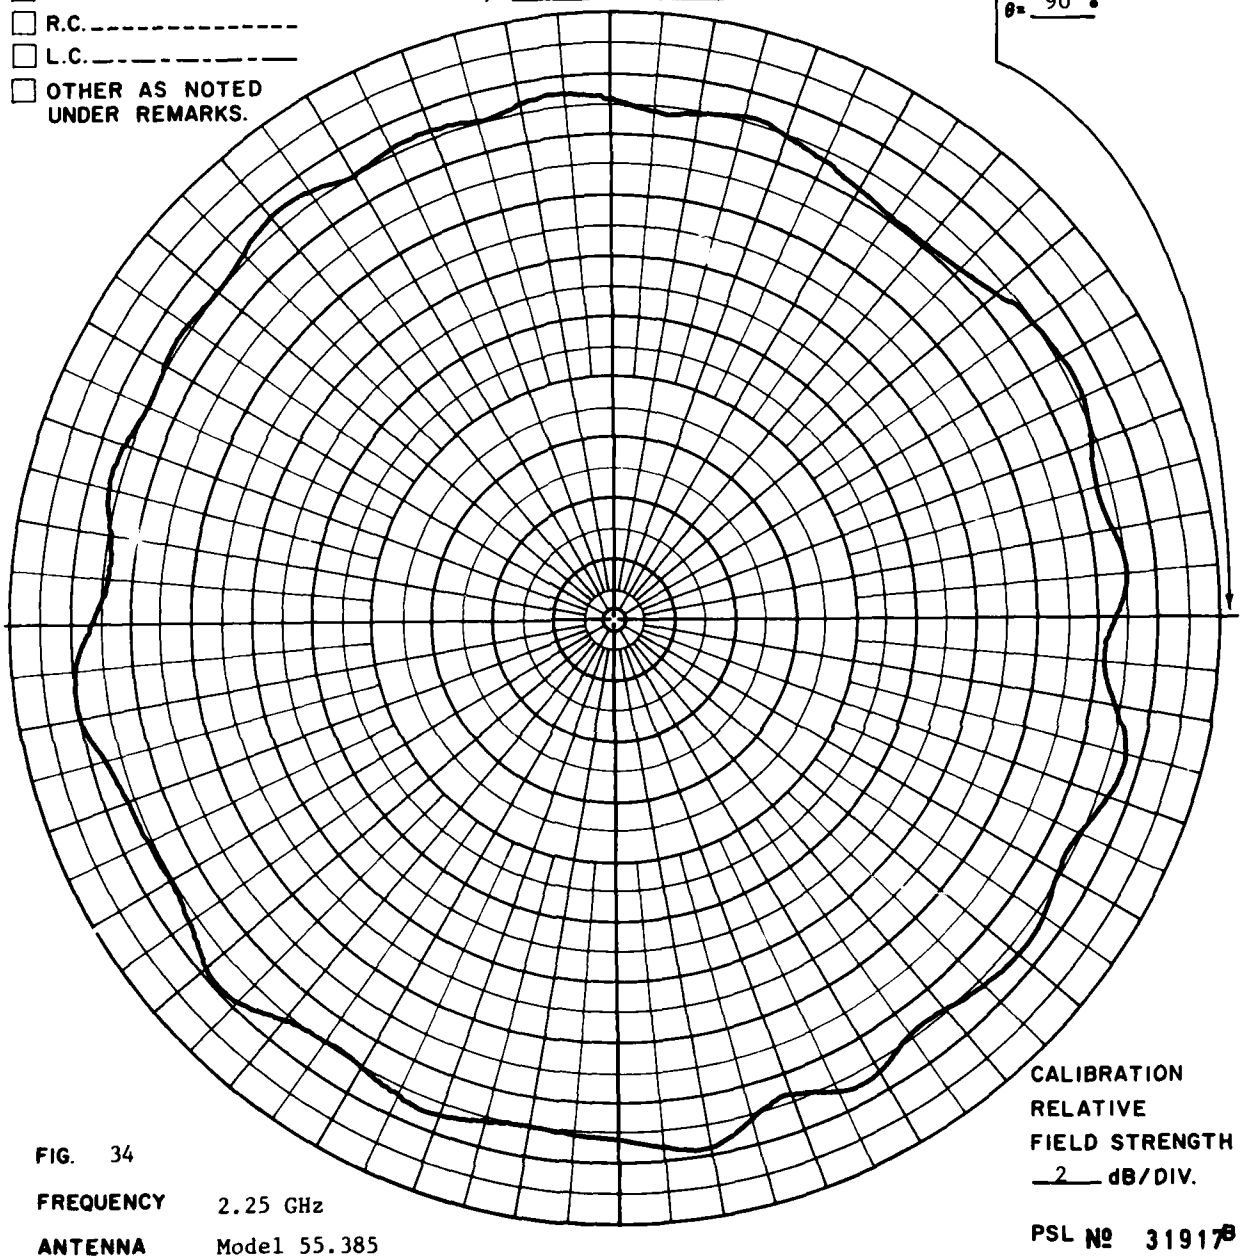
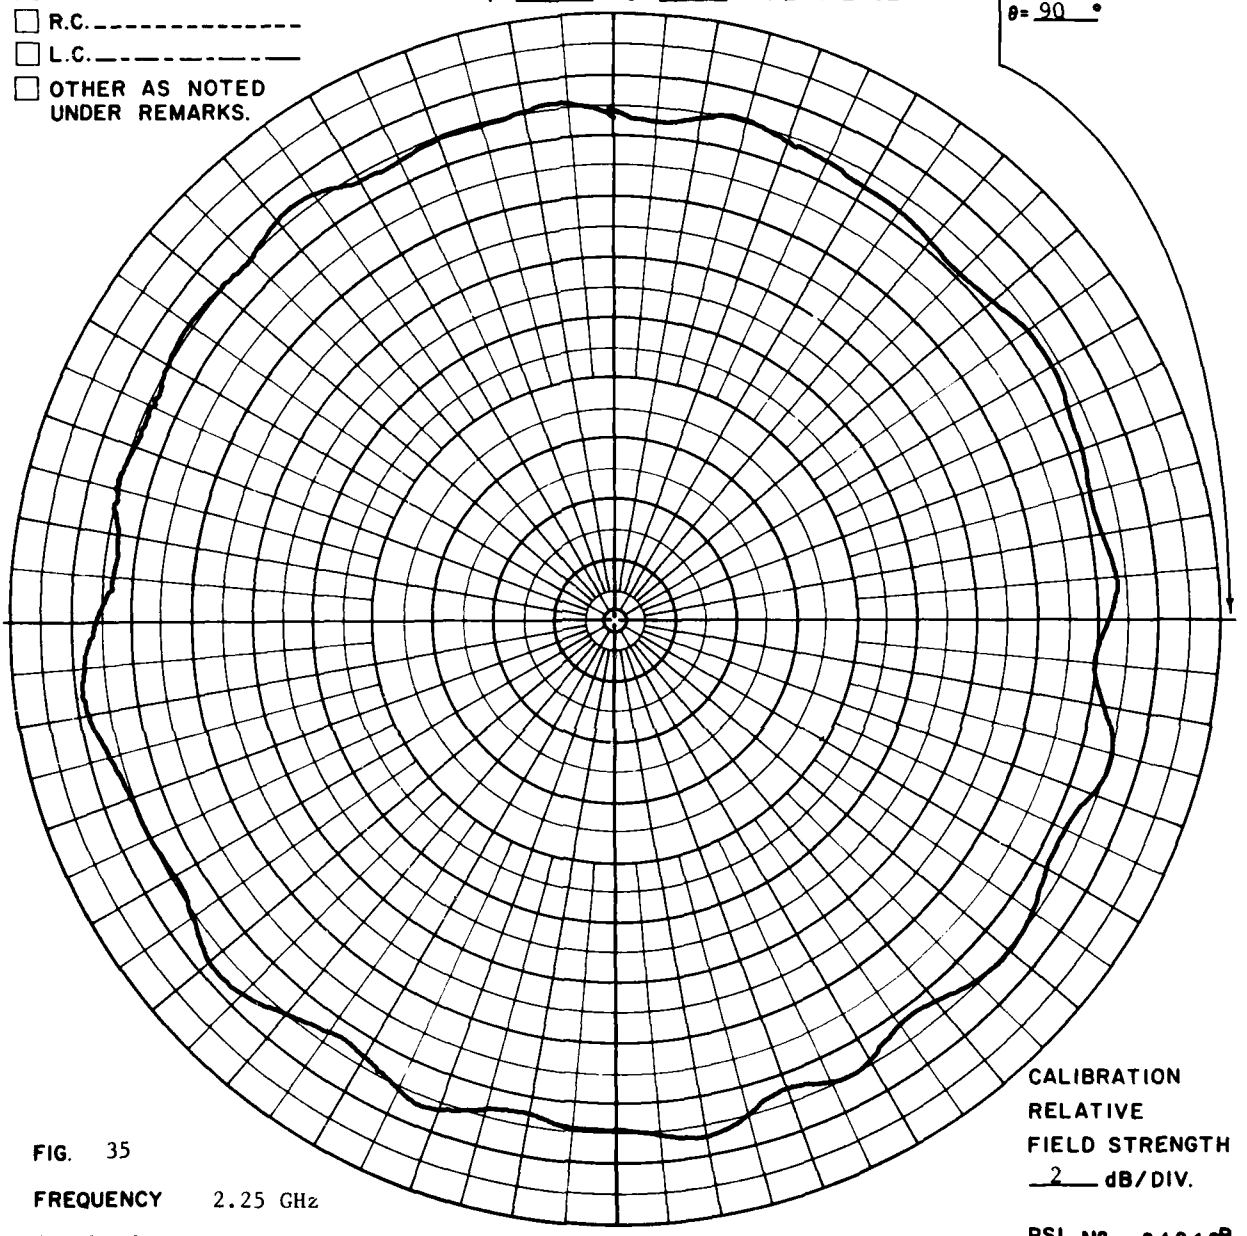
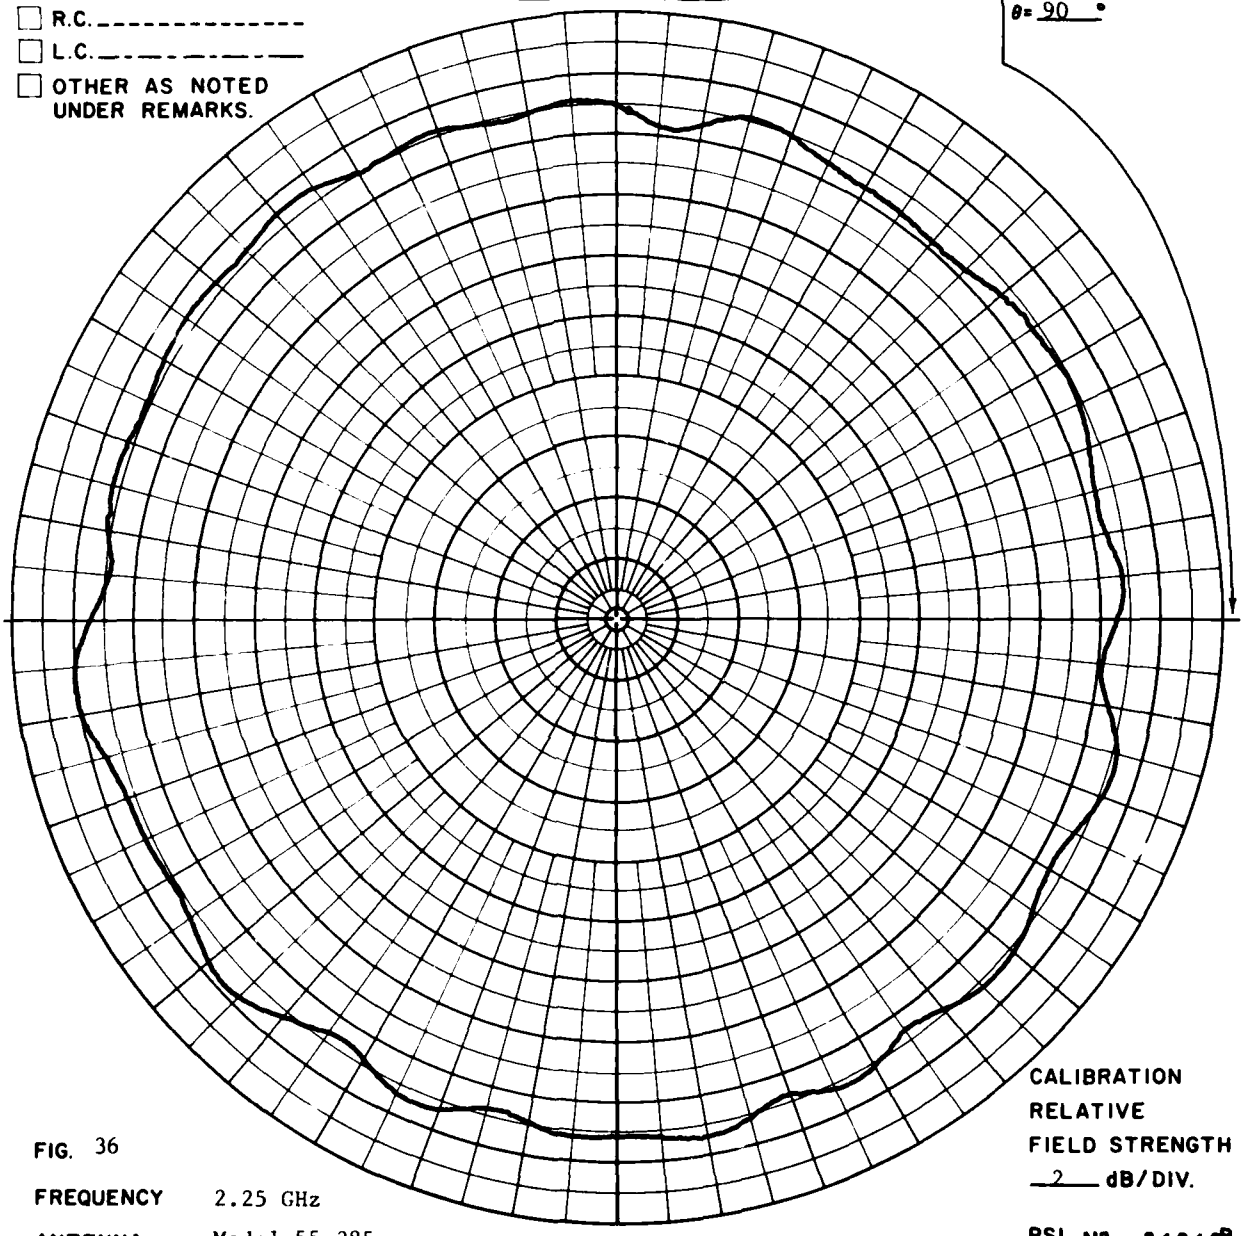
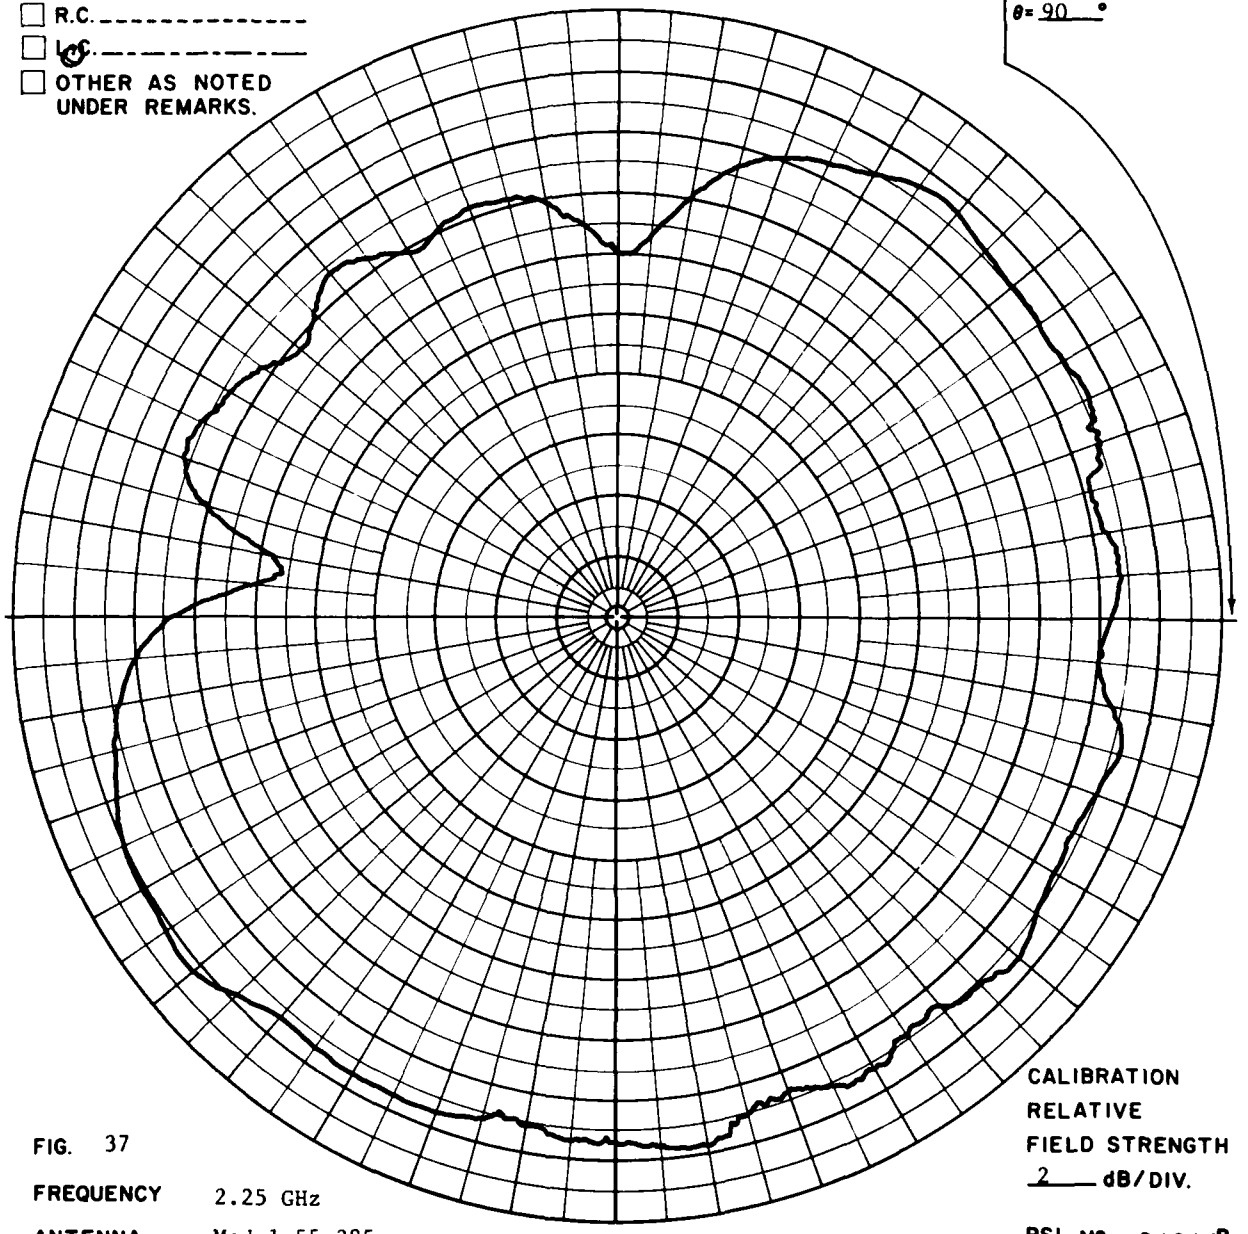
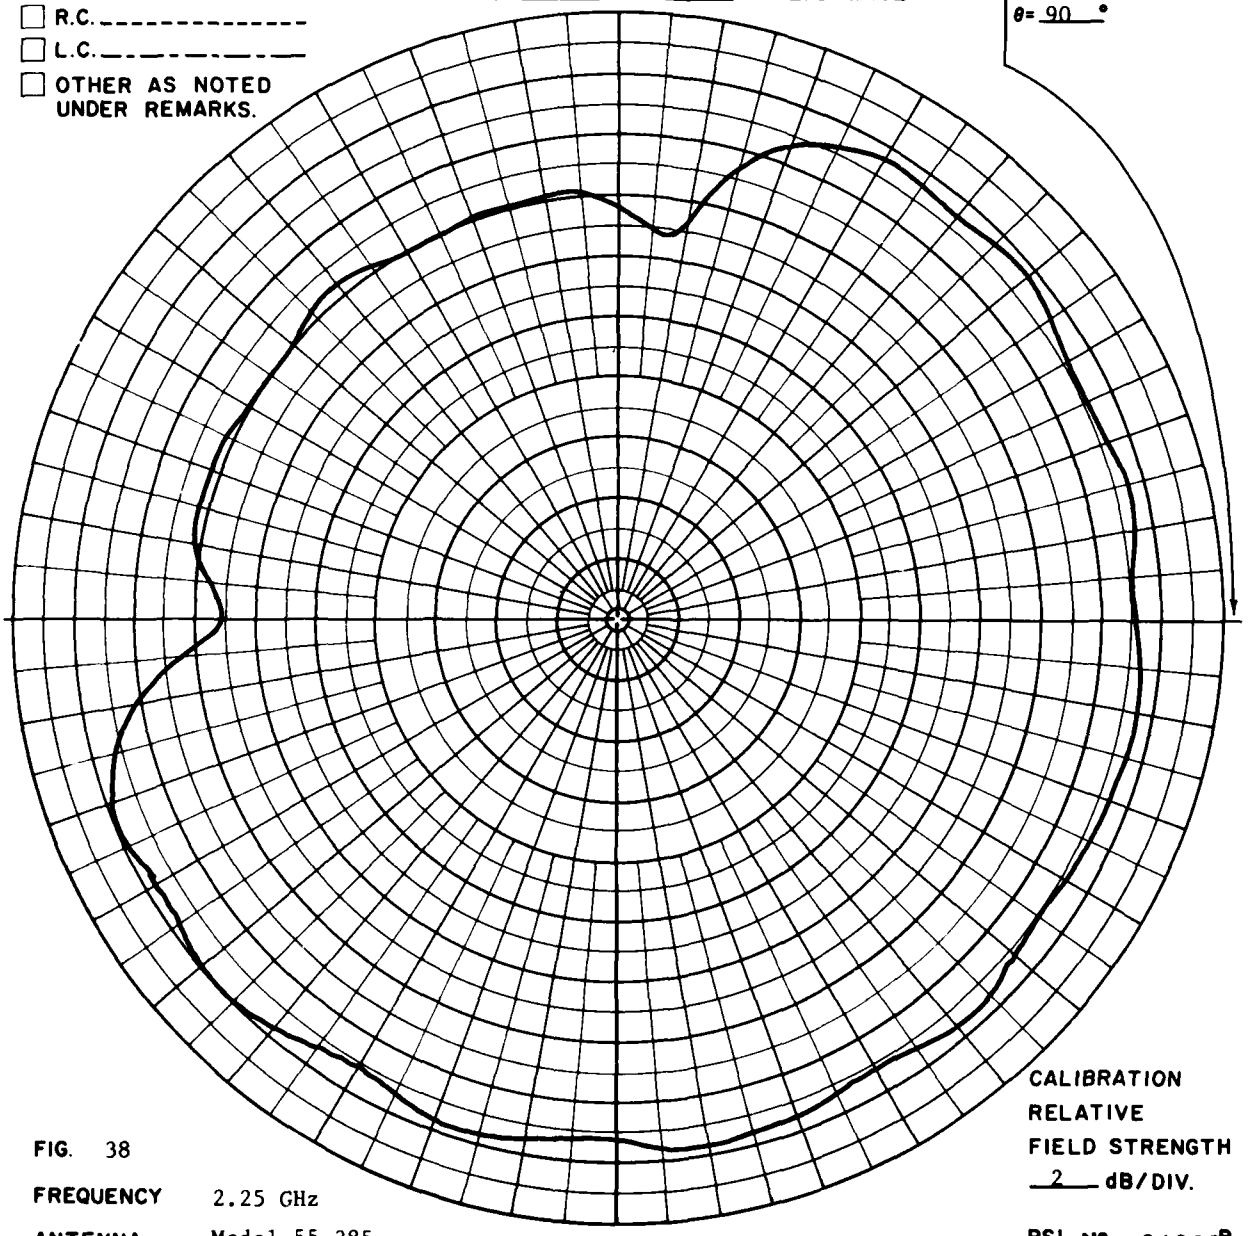
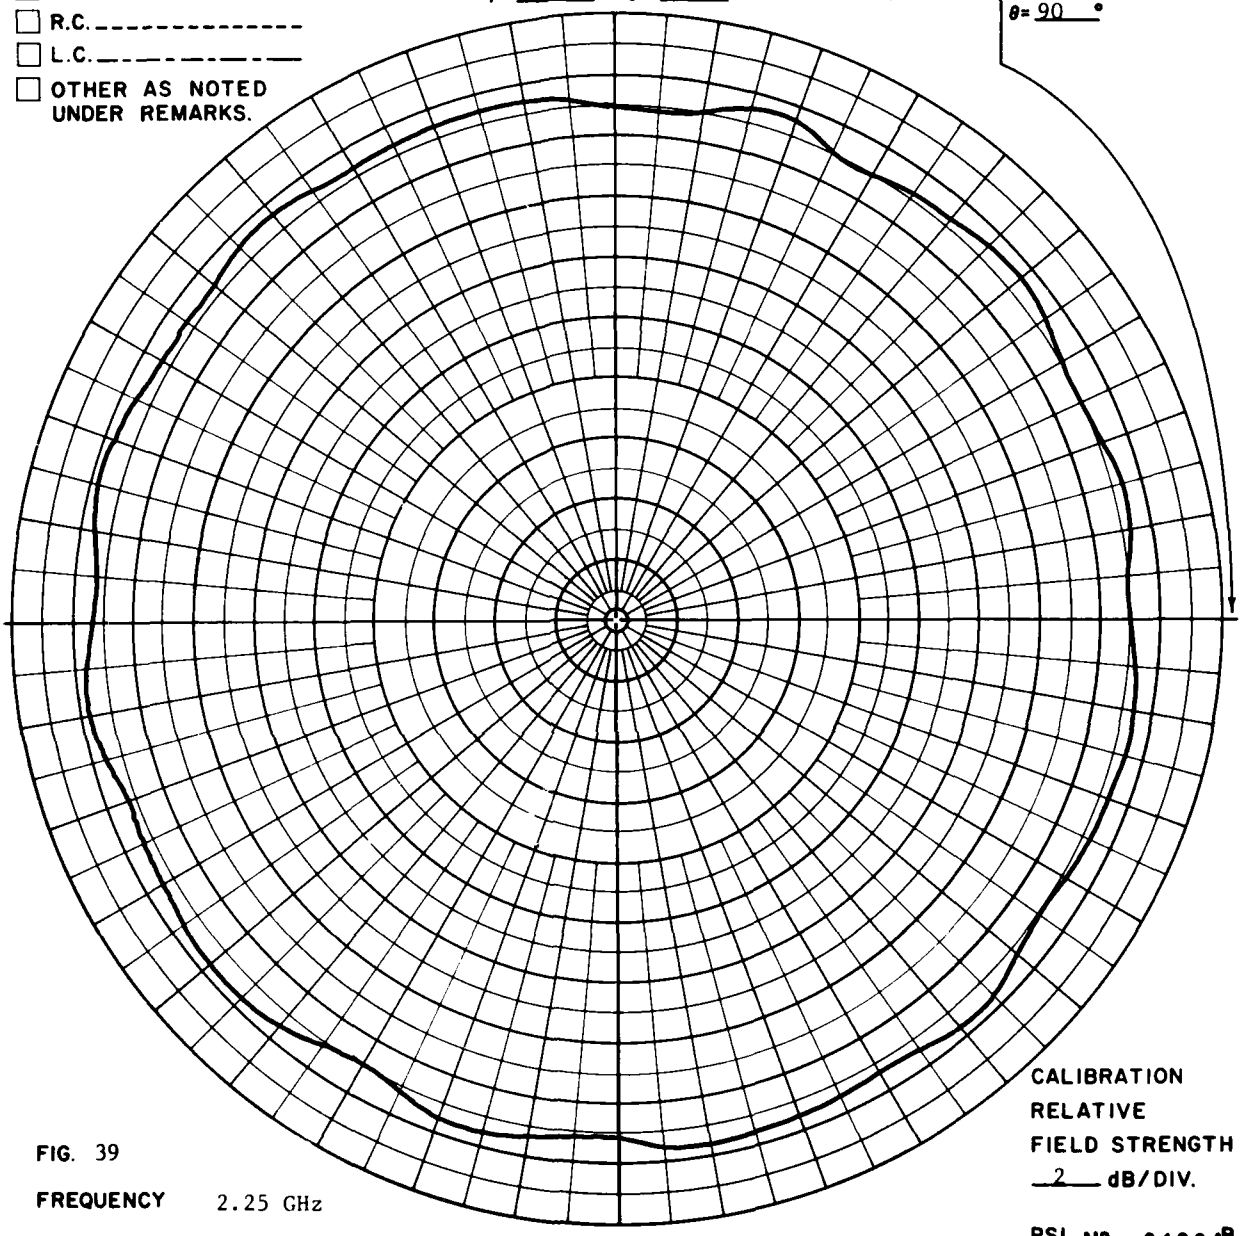
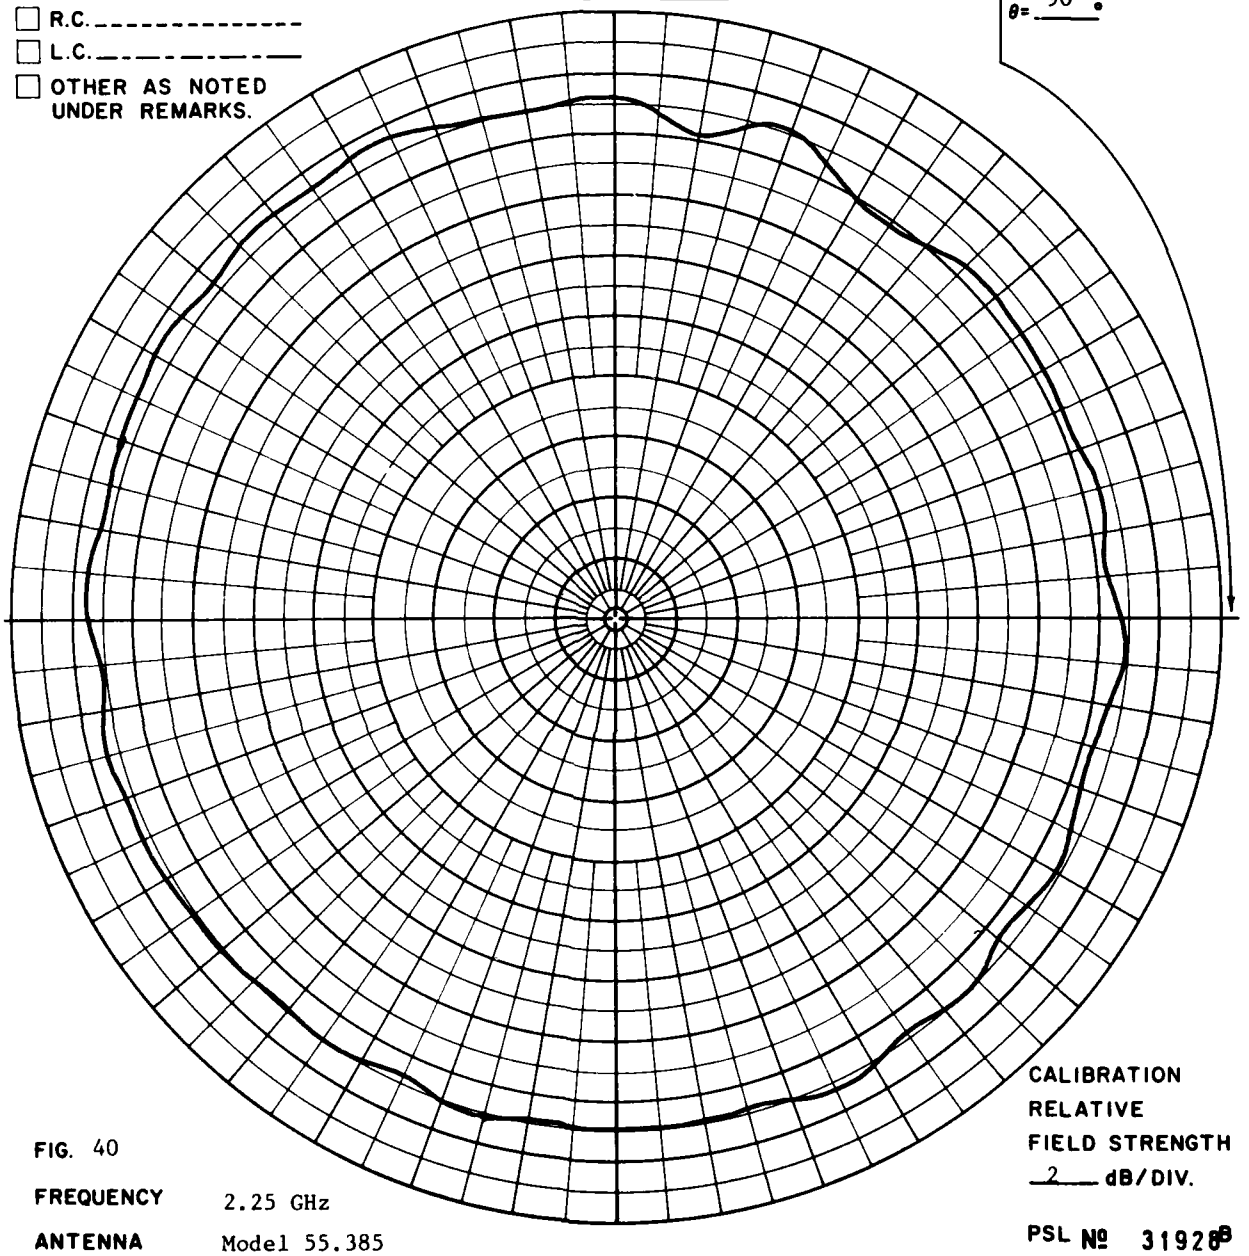
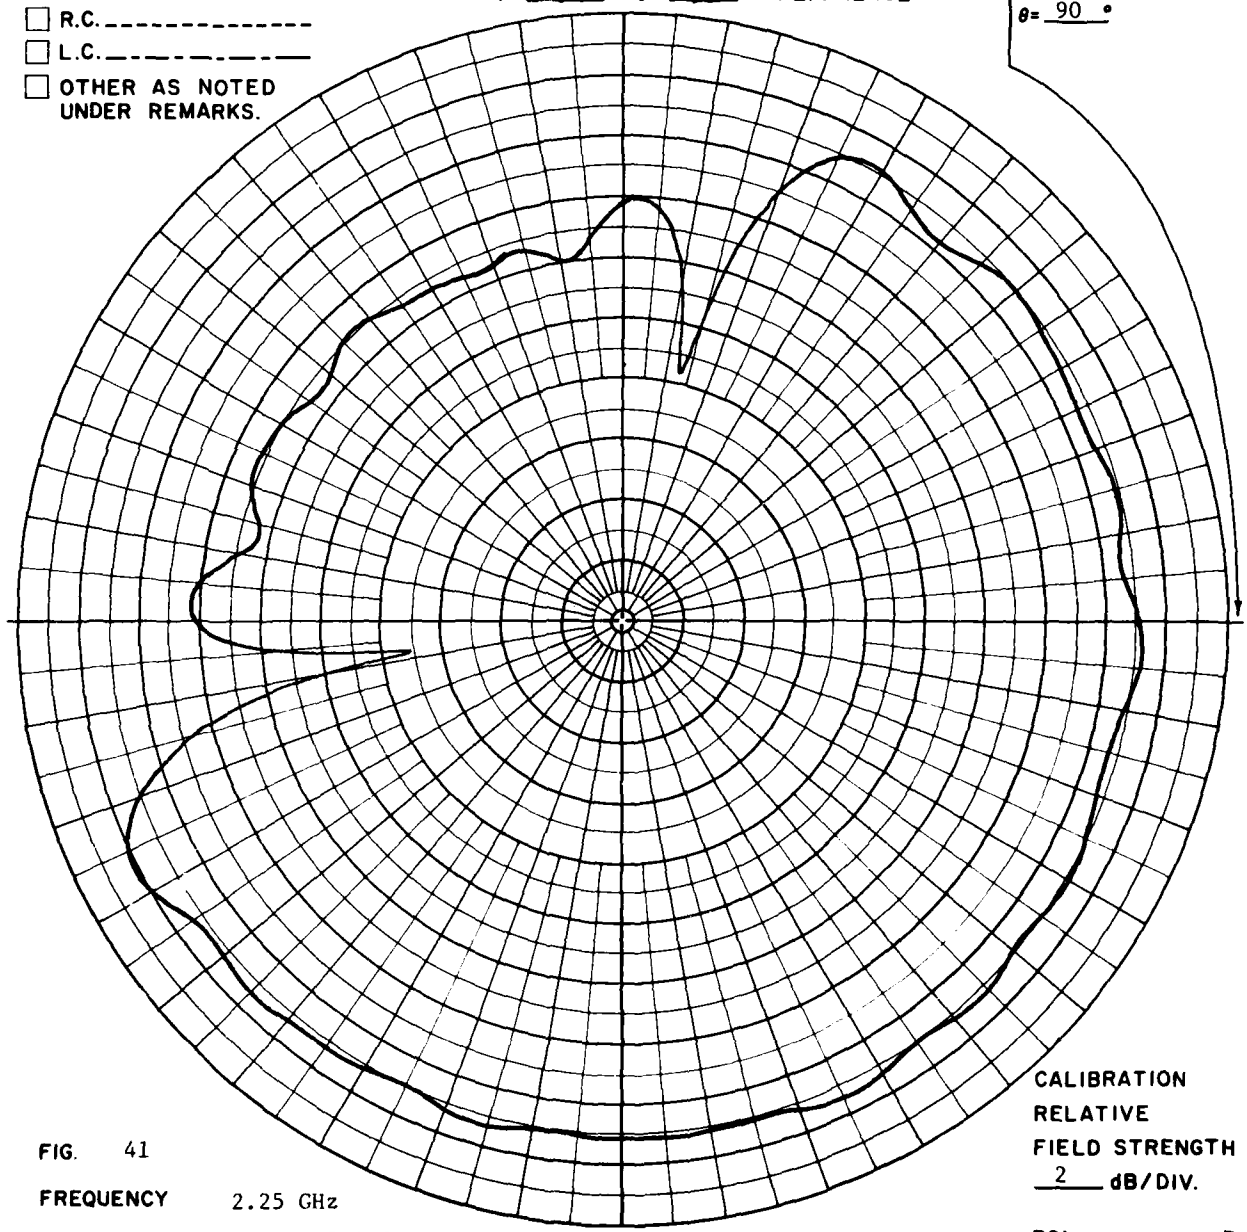
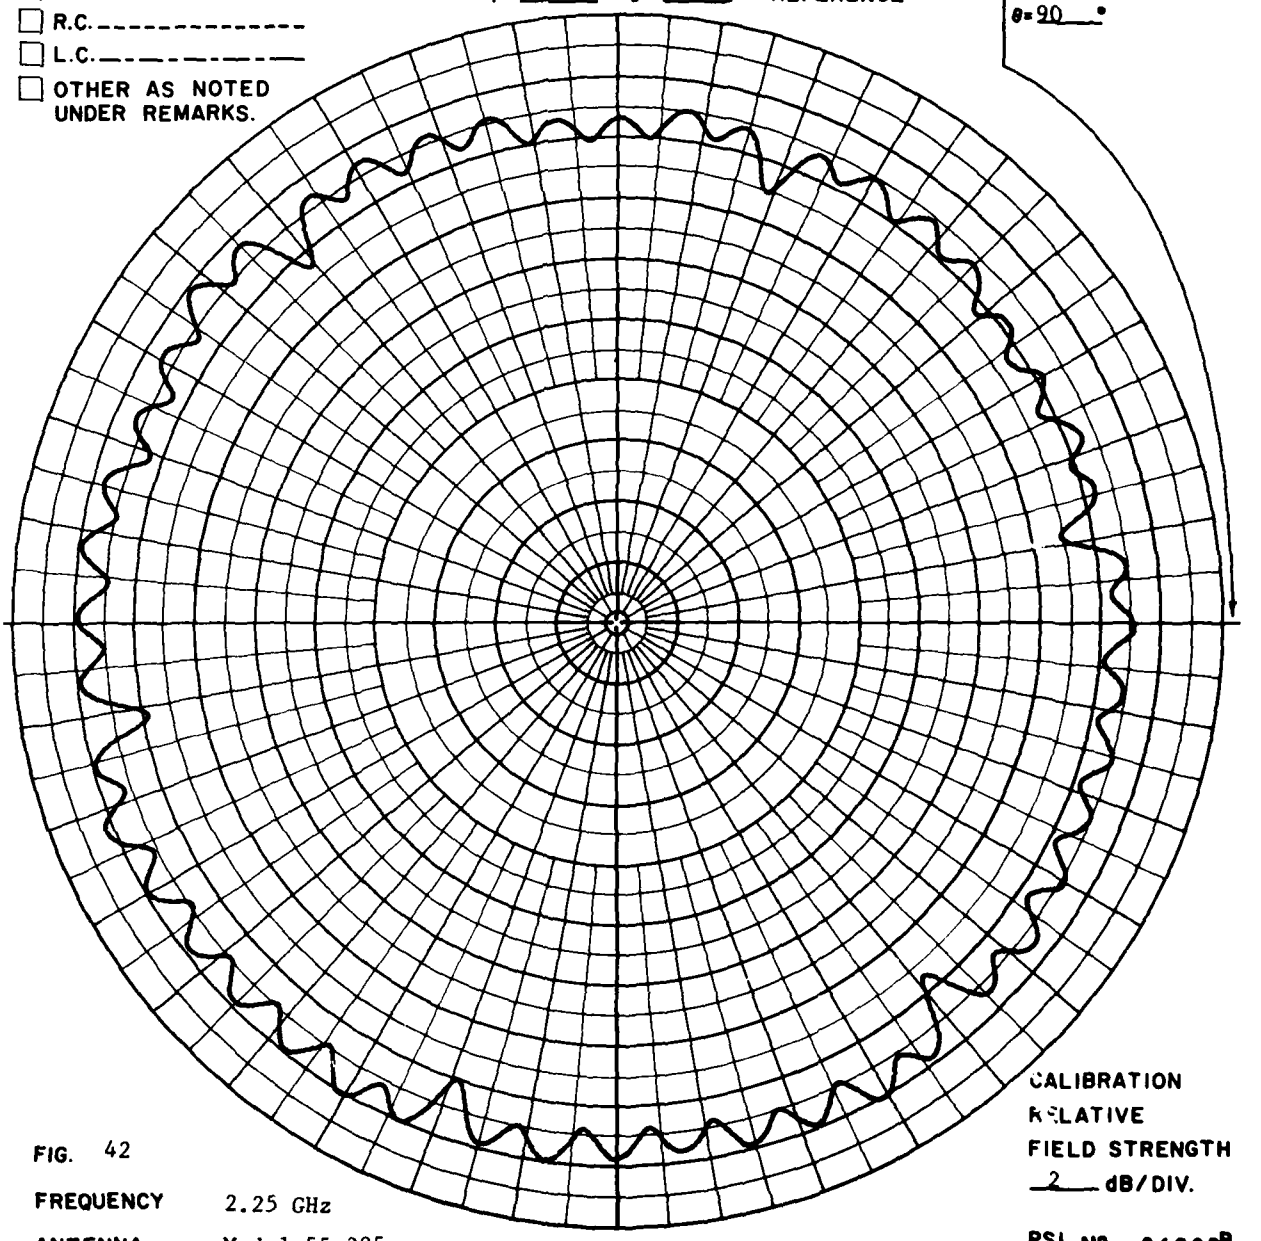
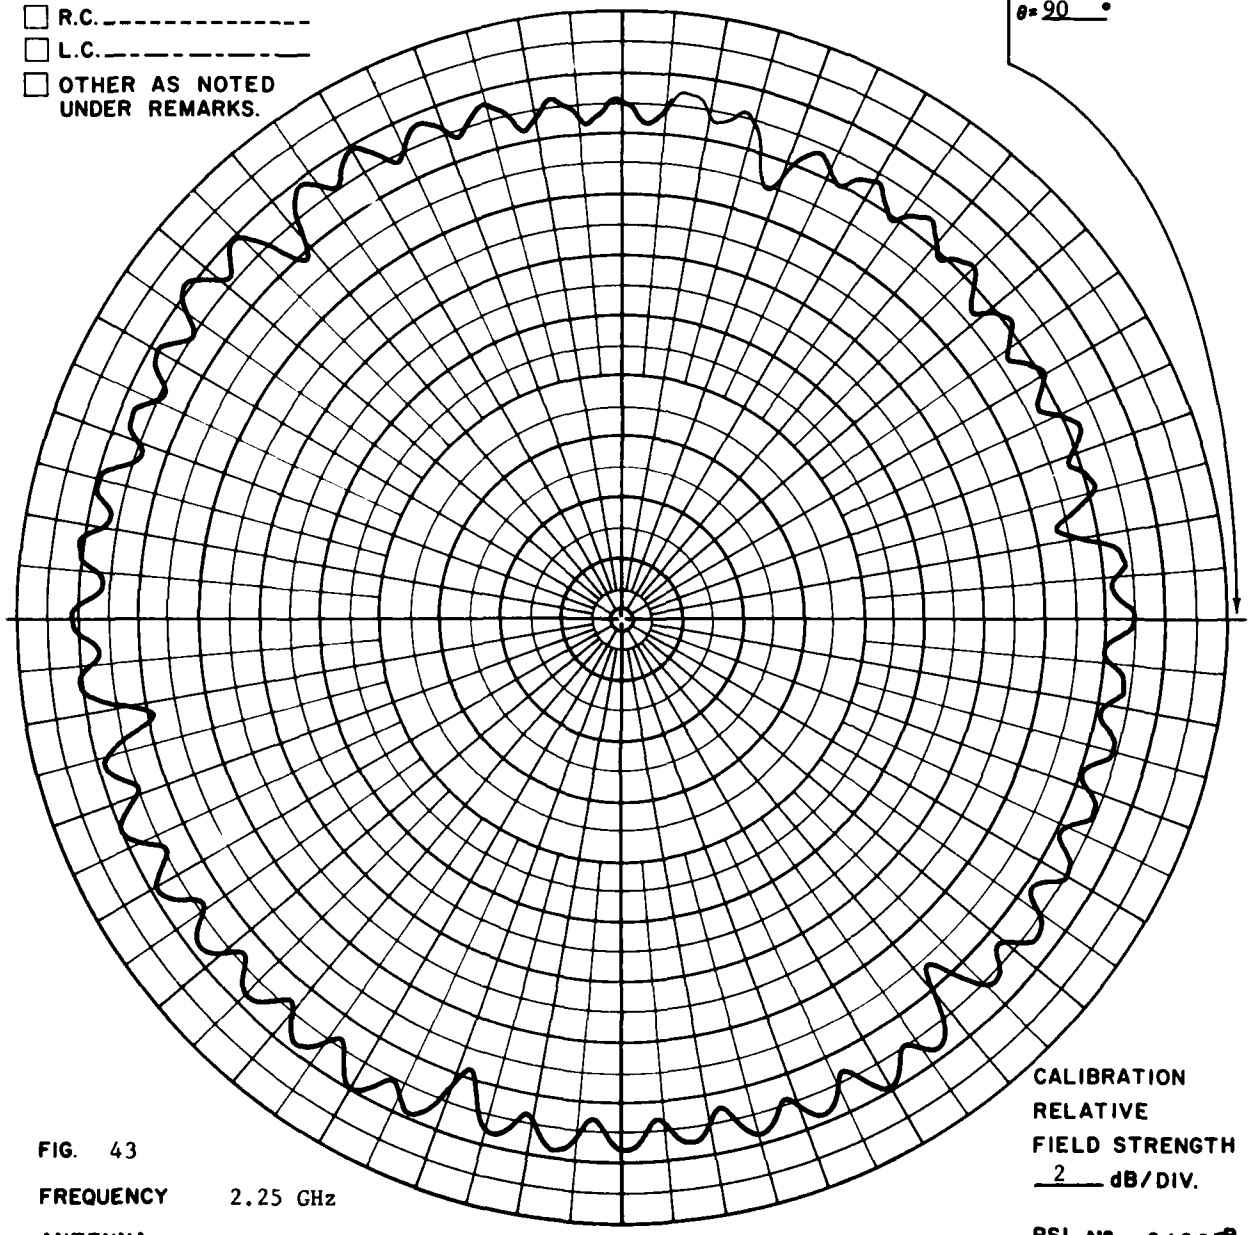
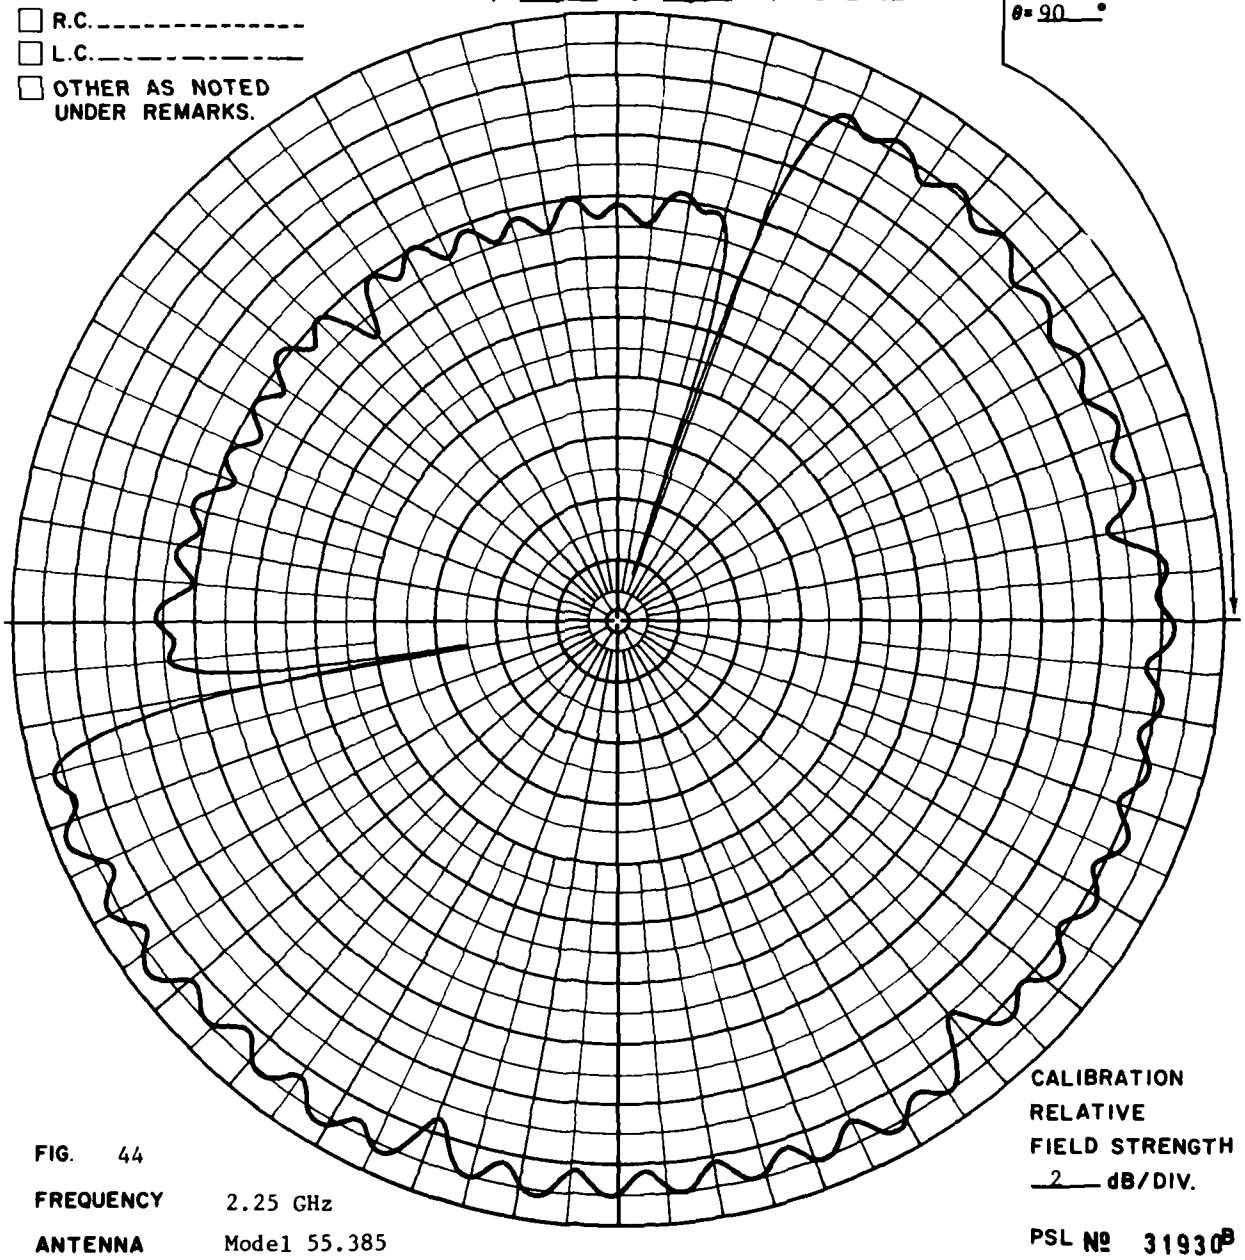
Another condition that may go undetected is illustrated by the patterns in Figures 33 through 44. The coaxial harness cables were deliberately bent and pinched as shown in Figure 32. This produced an intermittent problem which made detection uncertain. The implication is that great care needs to be exercised during the installation of the harness since a preflight probe is not a reliable method for detecting loose connectors or damaged cables.

REMARKS Near-field probe with coaxial to waveguide adaptor. Same cable conditions as with PSL 31921B (Fig. 37).

FREQUENCY	2.25 GHz
ANTENNA	Model 55.385
REMARKS	Near-field pattern. Coaxial to waveguide adaptor probe. Antenna and harness condition is the same as for pattern shown as PSL 31923B (Fig. 38).

REMARKS Near-field. Coaxial to waveguide adaptor probe. After additional handling of the damaged cable.

REMARKS Near-field pattern. Short dipole probe. Intact cables were replaced by the damaged cables. Note that the pattern shown in PSL 31928B (Fig. 40) did not repeat.

REMARKS Near-field. Short dipole probe. Same cable condition as for pattern PSL 31929B (Fig. 41).

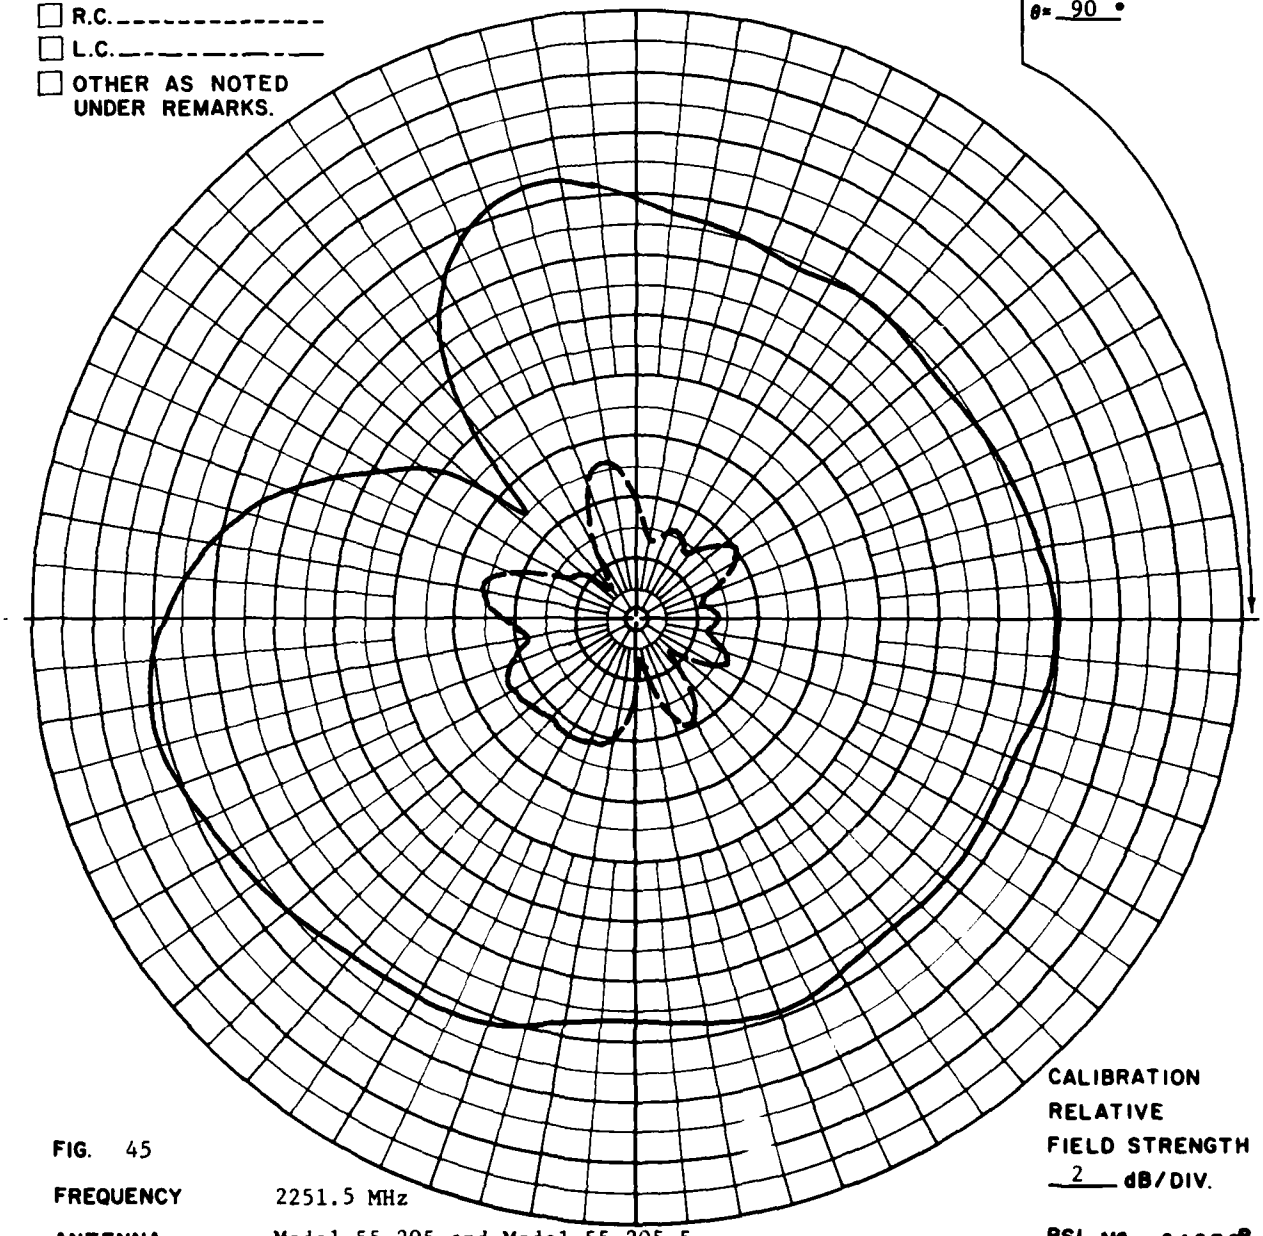
FIG. 45

Additional tests were made to determine how a faulty antenna mounting affects the radiation pattern. The antenna used was a Model 55.205 stripline slot array mounted on a 17 inch diameter vehicle. The antenna was mounted so that it did not make good contact with the vehicle skin; in one place there was a gap of about 0.050 inches between the antenna and the vehicle skin. The result is a deep minimum in the pattern. The far-field pattern was recorded at the antenna range and is shown in Figure 45.

Near-field probe tests were made in the laboratory but were not recorded. These tests illustrate the usefulness of the small dipole probe and its limitations. The results from the dipole probe showed that all elements were radiating, indicating that there were no damaged lines. But the tests gave no indication that the far-field pattern would be unsatisfactory. The reason for this is that the probe is so close to the antenna that it only detects the signal from each individual slot. The test with the open-ended waveguide probe did show the null in the pattern; that is, it gave a good correlation with the far-field pattern. The combination of the two tests, dipole and open-ended waveguide, made it easier to locate the problem. The short dipole did exclude a faulty harness or antenna, and the waveguide indicated that there would be a null in the pattern. This led to the conclusion that there must be another source causing an interference null. The problem was identified as a small gap between the antenna and the vehicle. This illustrates that the probes may be used together as a diagnostic tool. It should be emphasized that the small dipole located close to the test antenna should not be used as the sole testing device.
